# Manhole Inspection Summary

Manhole # S59K\_\_016MH

**Inspection** ☐ Is Incomplete Rating: **5) Immediate Attention Required**

**Location** Address: **rear 4500 fait ave**

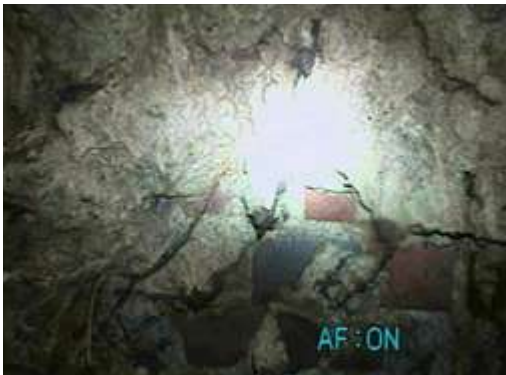
Defect 6

Condition: ☐ Sound ☐ Cracked ☒ **Root Intrusion** ☐ Loose Brick ☐ Deteriorated

barrel wall

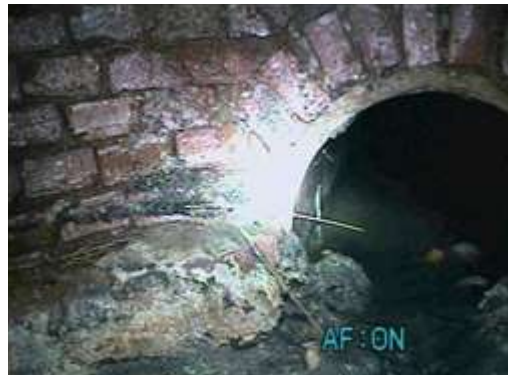
Defect 5

Condition: ☐ Sound ☐ Cracked ☐ Root Intrusion ☐ Deteriorated ☐ Leaks ☒ **Debris**

channel debris

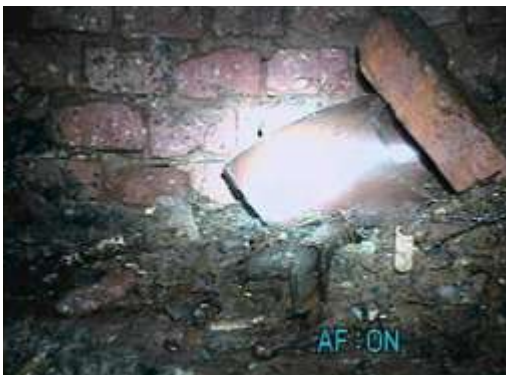
Defect 4

Condition: ☐ Sound ☐ Cracked ☐ Root Intrusion ☐ Deteriorated ☐ Leaks ☒ **Debris**

bench debris

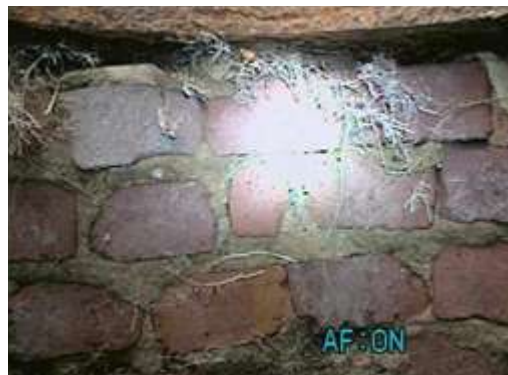
Defect 3

Condition: ☐ Sound ☐ Cracked ☒ **Root Intrusion** ☐ Loose Brick ☐ Deteriorated

frame adj with roots from under frame

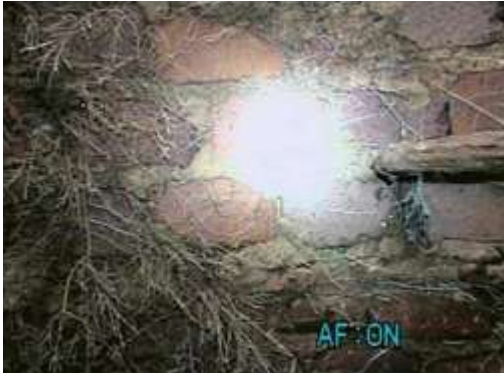
Defect 2

Condition: ☐ Sound ☐ Cracked ☒ **Root Intrusion** ☐ Loose Brick ☐ Deteriorated

roots in corbel wall

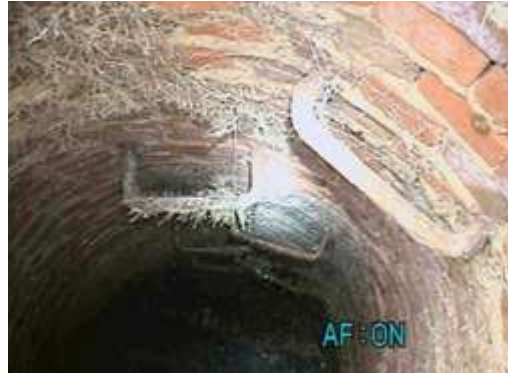
Defect 1

Comments **Roots are all over the manhole**

**Steps** Count: **7** Missing: **0** ☒ **Corroded**

steps & a massive amount of roots IN  
CHIMNEY

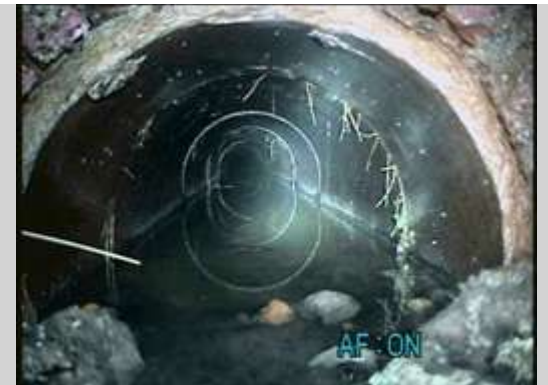
3 O'Clock Inflow

Infiltration: **Evidence** Pipe Seal Cond: **Roots**
